DEPARTMENT OF TRANSPORTATION**DIVISION OF ENGINEERING SERVICES**

Contract #: 04-0120F4Cty: SF/ALA Rte: 80 PM: 13.2/13.9File #: 13.28**WELDING INSPECTION REPORT****Resident Engineer:**Pursell, Gary**Address:** 333 Burma Road**City:** Oakland, CA 94607**Report No:** WIR-006547**Date Inspected:** 01-May-2009**Project Name:** SAS Superstructure**OSM Arrival Time:** 700**Prime Contractor:** American Bridge/Fluor Enterprises, a JV**OSM Departure Time:** 1530**Contractor:** Oregon Iron Works Clackamas, Or.**Location:** Clackamas, OR**CWI Name:** Mike Gregson, Rob Walters**CWI Present:** Yes No**Inspected CWI report:** Yes No N/A**Rod Oven in Use:** Yes No N/A**Electrode to specification:** Yes No N/A**Weld Procedures Followed:** Yes No N/A**Qualified Welders:** Yes No N/A**Verified Joint Fit-up:** Yes No N/A**Approved Drawings:** Yes No N/A**Approved WPS:** Yes No N/A**Delayed / Cancelled:** Yes No N/A**Bridge No:** 34-0006**Component:** Hinge K Pipe Beams**Summary of Items Observed:**

Hinge-K Pipe Beam Assembly 102A-1: 5/01/09

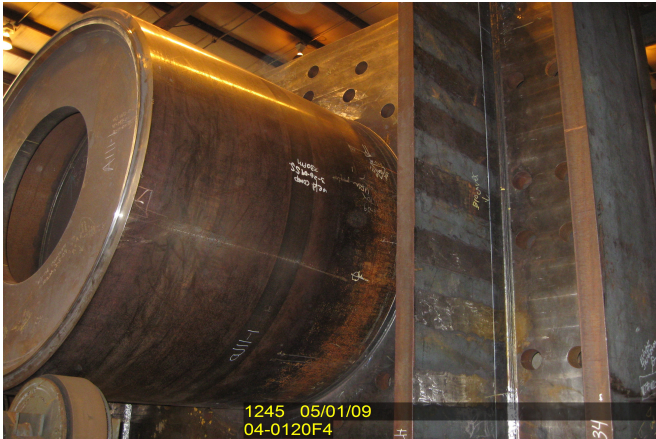
QA Inspector randomly witnessed OIW welder #T23, Mr. John Tellone backgouging on weld repair that was previously ultrasonically inspected and rejected by QC Inspector Steve Barnett.

QA Inspector noted this was a CJP (AWS D1.5 TC-U9a-S) a11-1 forging to a110-2 base plate, designated as weld joint #W2-12 & W2-13 and QA Inspector witnessed QC Inspector Rob Walter was present to verify pre-heat temperature was a minimum 66C (151F), which is compliance with the applicable OIW approved welding procedure specification (WPS 3046). QA Inspector spoke with QC Inspector Rob Walters and Mr. Walters explained the backgouge depth/length would be verified and magnetic particle testing would be performed, prior to welding.

See picture below after excavation is complete and assembly was moved in preparation for welding.

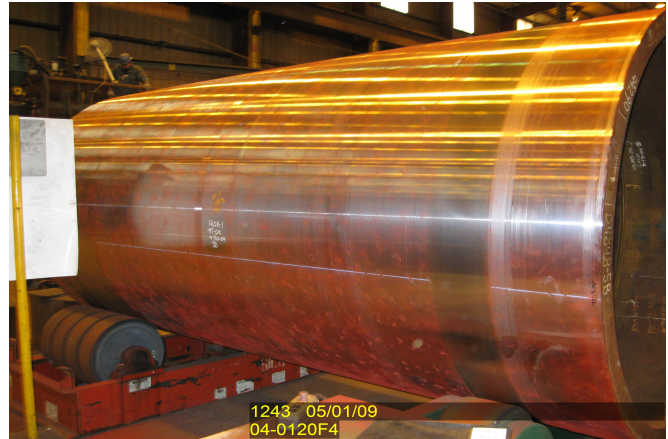
Hinge-K Pipe Beam Fuse Assembly 120A-1: 5/01/09

QA Inspector noticed this fuse assembly 120A-1 had arrived at OIW fabrication shop on 4/30/09 and 100% magnetic particle testing was performed by swing shift QC Inspector Steve Barnett on the exterior of fuse assembly 120A-1, after rough machining was complete by A&G and no rejectable indications were found.

QA Inspector noted Mr. Barnett had completed the applicable magnetic testing report and QA Inspector performed approximately 10% magnetic particle testing on the exterior of fuse assembly 120A-1 and found no rejectable indications. See applicable magnetic testing report (TL6028) for additional details and see picture below of fuse assembly 120A-1, after rough machining and 100% magnetic particle testing was complete.
